# Creek & Communities: A Freshwater Imperative

Shawnigan Lake Watershed Roundtable  
Aqua-Tex Scientific Consulting Ltd.  
September, 2012

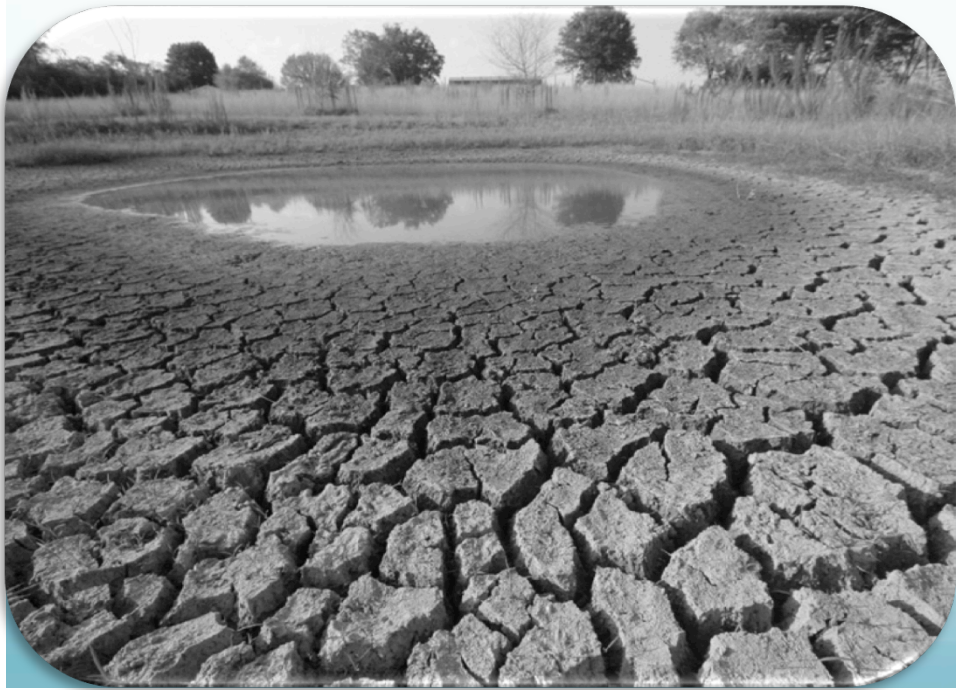
Altering the landscape from its natural form results in:

- Reduced ground-water infiltration and recharge
- Aging of the landscape (nutrient cycle becomes linear)
- Increased surface run-off
- Reduction in green space
- Heat island effect
- Local climate change

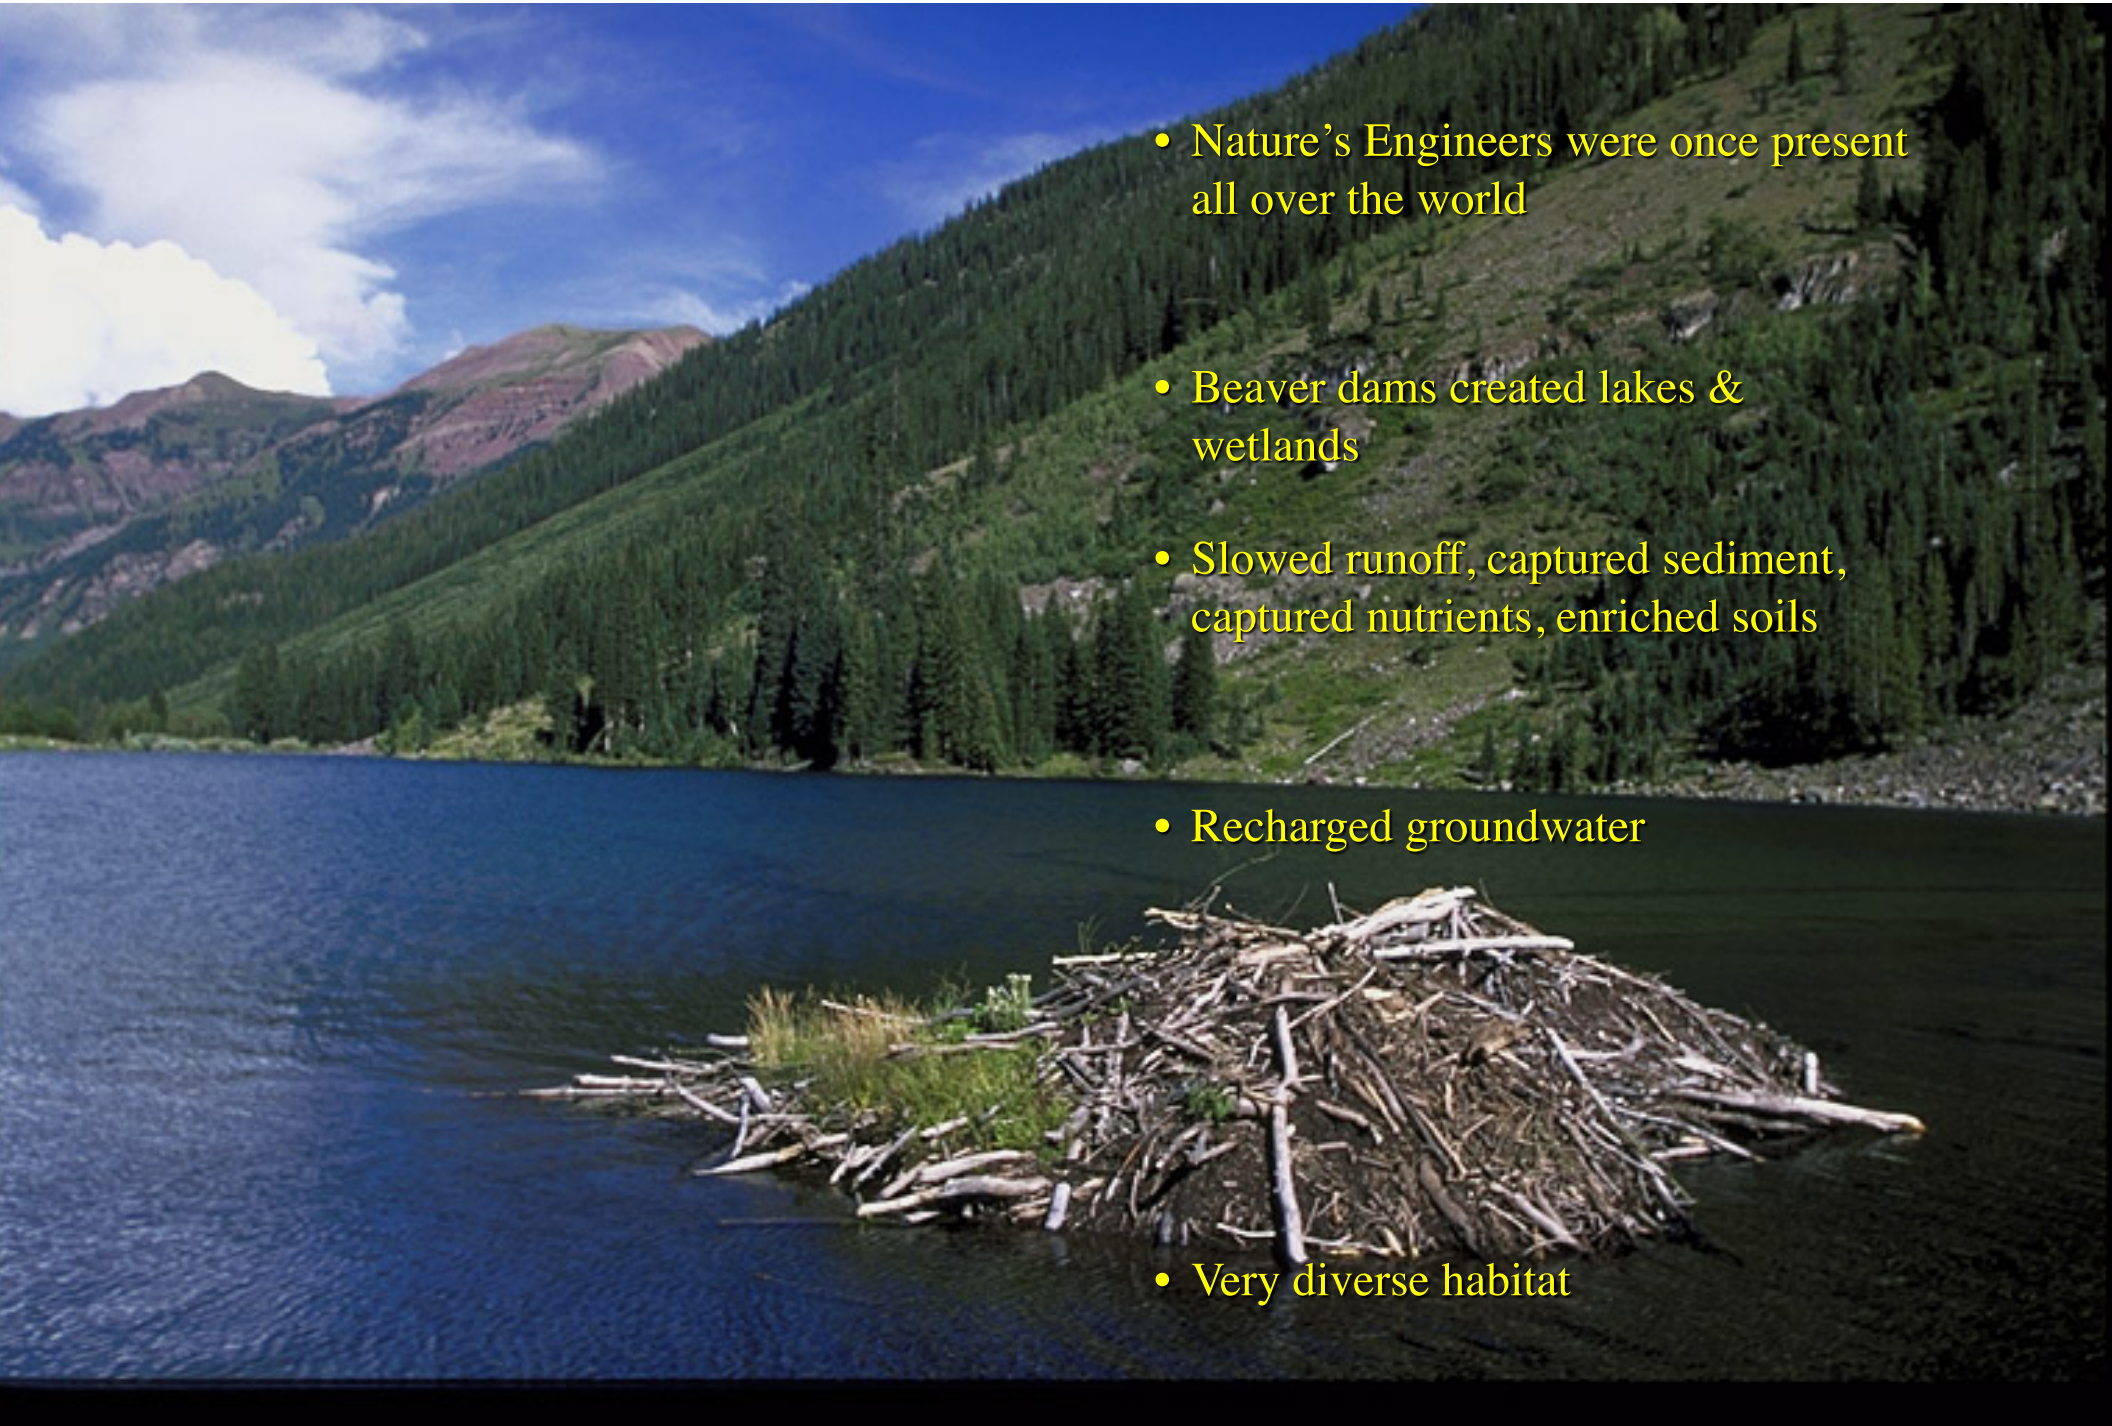
- Nature's Engineers were once present all over the world
- Beaver dams created lakes & wetlands
- Slowed runoff, captured sediment, captured nutrients, enriched soils
- Recharged groundwater
- Very diverse habitat

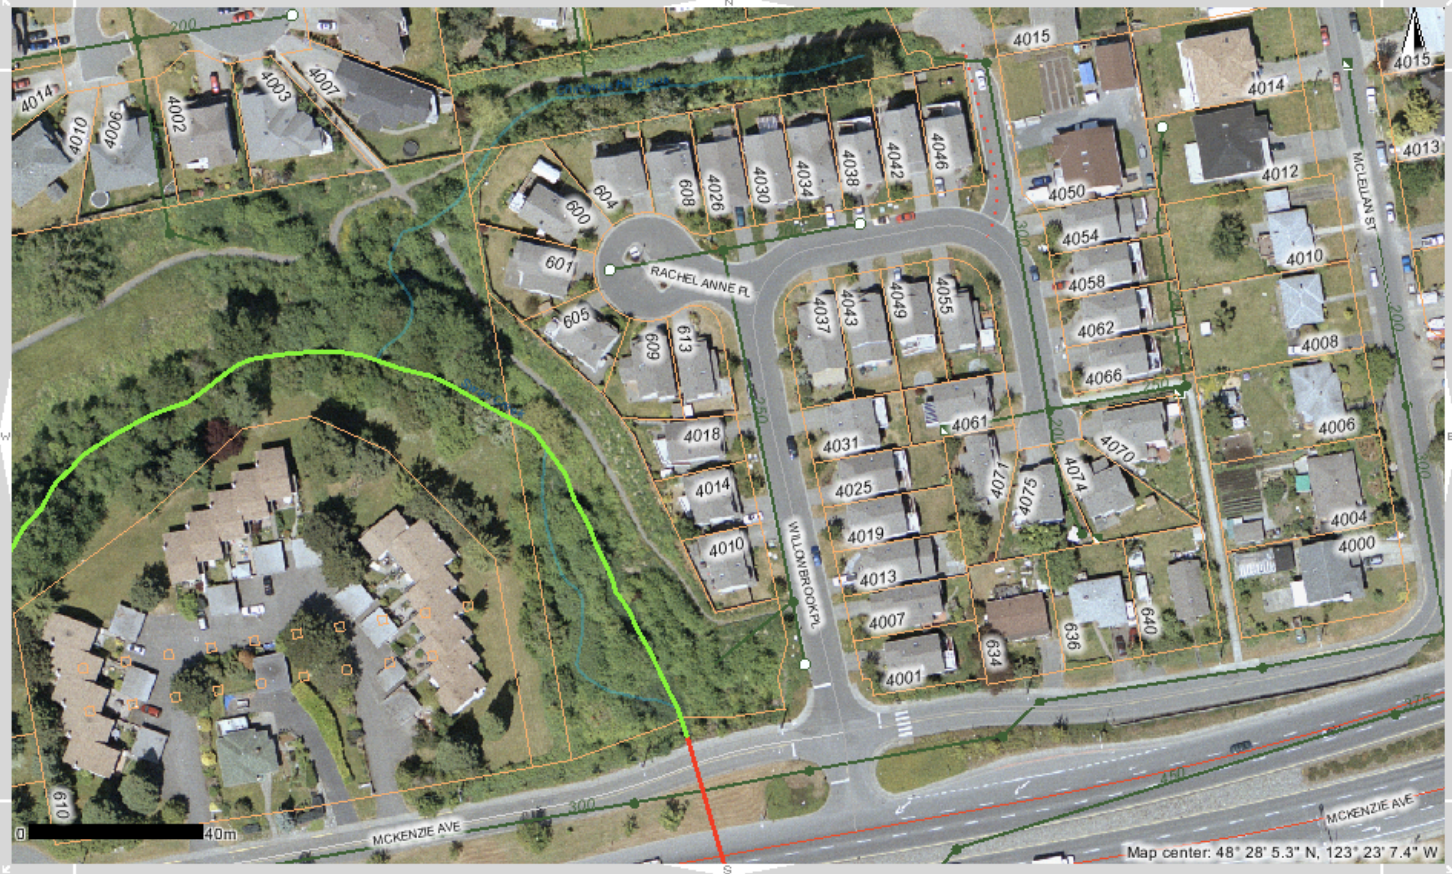
Scale: 1: 1,003  Map Tool:  Active Layer: **Functioning Condition - Lotic**

The following information was excerpted from the report entitled "Colquitz River Watershed: Proper Functioning Condition Assessment July 2009" prepared by Aqua-Tex Scientific Consulting Ltd. (www.aqua-tex.ca) for the District of Saanich. This project was funded by the Federation of Canadian Municipalities and the Real Estate Foundation of B.C.

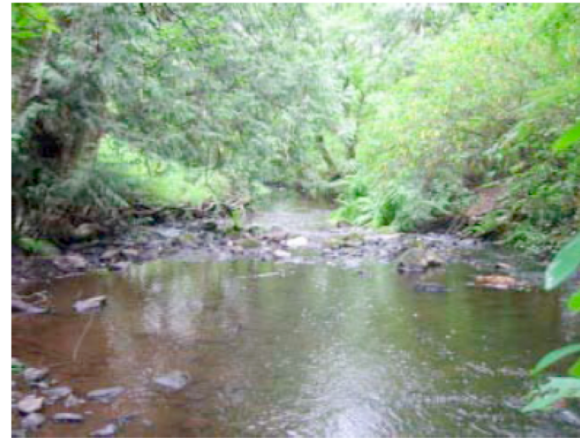
Colquitz River Reach 11, Photo 2, 2007-07-23.  
Facing downstream. The hydrology of the creek is altered (hence the reach break) at this point due to the change in substrate.

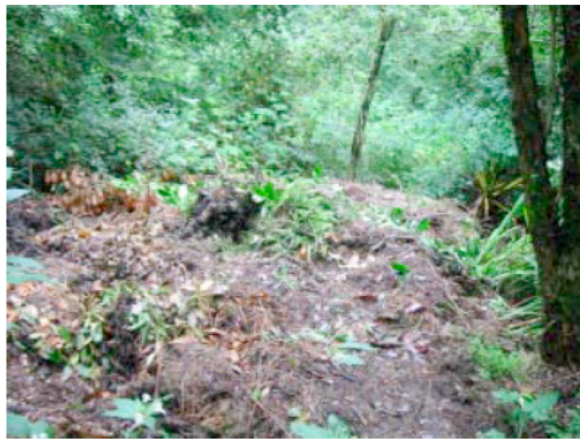
Colquitz River Reach 11, Photo 3, 2007-07-23.  
Adjacent to Lindsay Road, residences have been dumping yard waste.

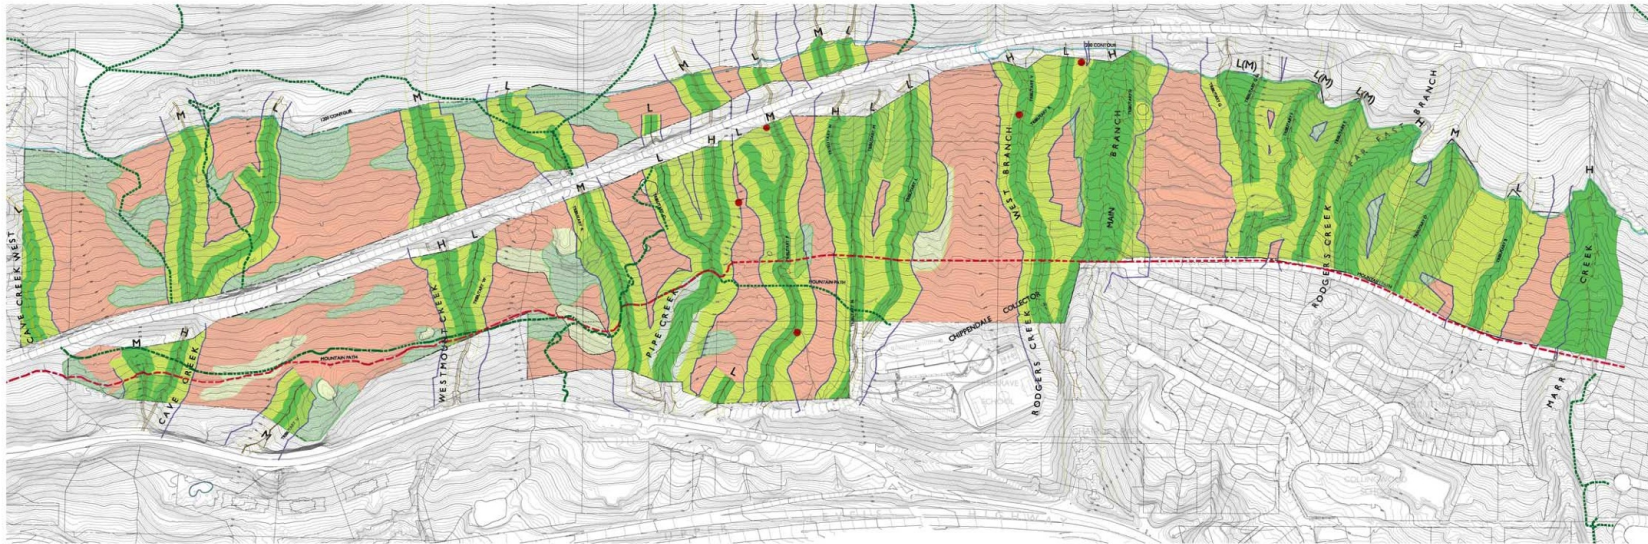
**Sieve Methodology**

The sieve analysis has been a work in progress and has been refined a number of times. The original sieve analysis was prepared in collaboration with the land owners and District staff in an intensive workshop session.

Each watercourse was evaluated as a collaborative process at technical meetings, including detailed field review, and categorized with respect to its environmental values as H (high), M (moderate), or L (low).

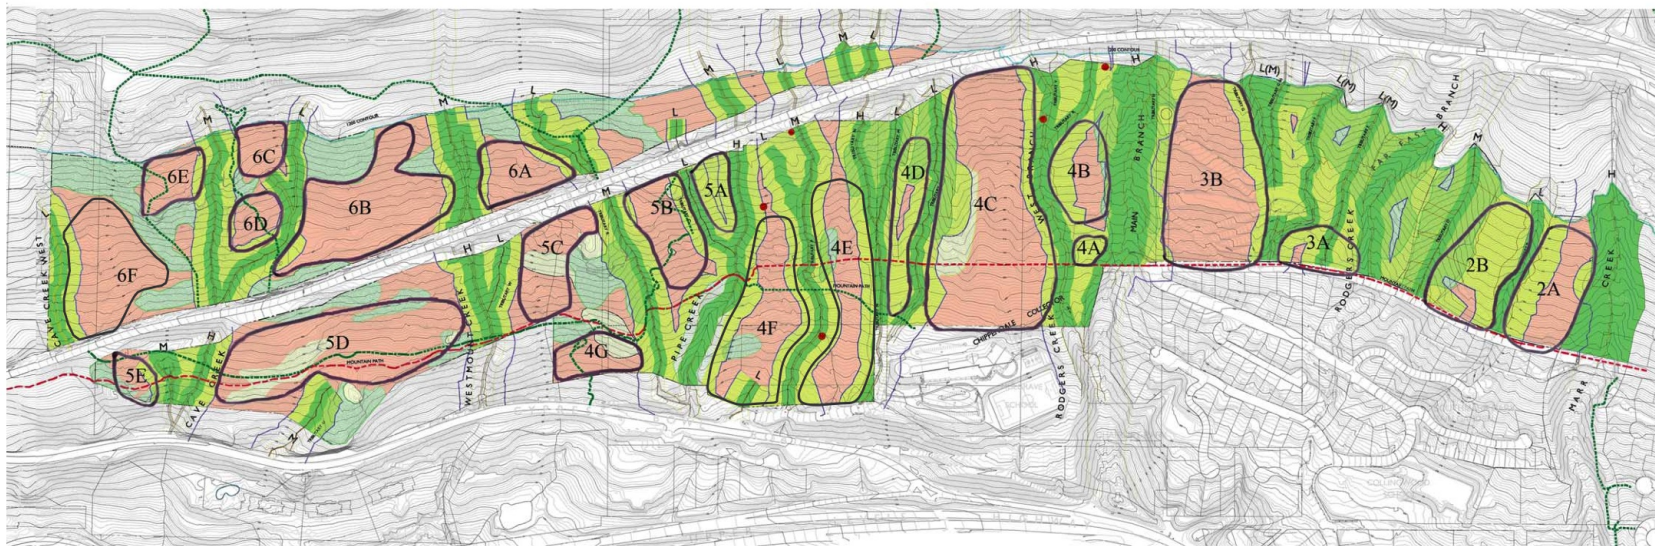
### Preliminary Planning and Conservation Areas

Working together, District staff and the Rodgers Creek land owners identified areas where development planning should focus. These development planning areas are enclosed in black outlines on the above map. The configuration of these potential development areas depends on the confirmation of road alignments, especially for the extension of the Chippendale connector road. District staff have not approved development within all of the areas shown. Final boundaries will be determined at the Development Permit stage and may be smaller than the areas shown, resulting in more conservation area being transferred to the District. Lands outside of the outlines will not be developed and will be preserved and enhanced.

The preliminary planning areas have been numbered and lettered for reference purposes.
